INSPECTION REPORT

For the Property at:
8309 NORTHWEST 123RD
PARKLAND, FL 33076

Prepared for: SAMPLE REPORT
Inspection Date: Friday, August 28, 2020
Prepared by: RONALD GLADDEN, HI12801

RE: Report No. 1055
8309 Northwest 123rd
Parkland, FL
33076

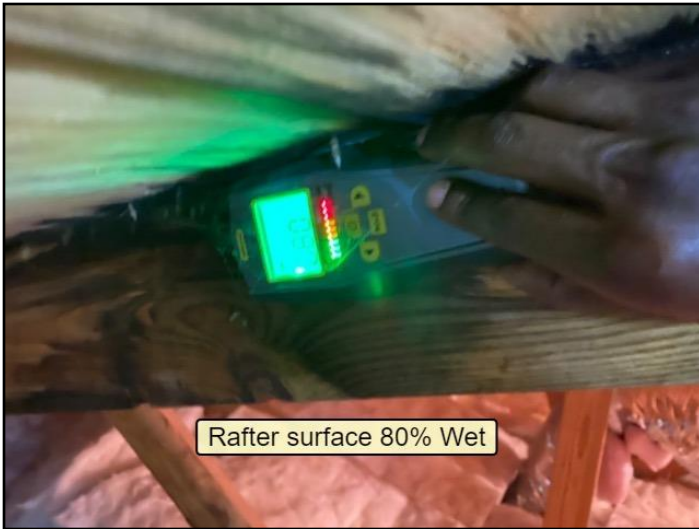
Roof decking and rafter was wet during the inspection. Possible roof leak. Recommend further evaluation be conducted by a licensed roofing contractor.

18. Leak

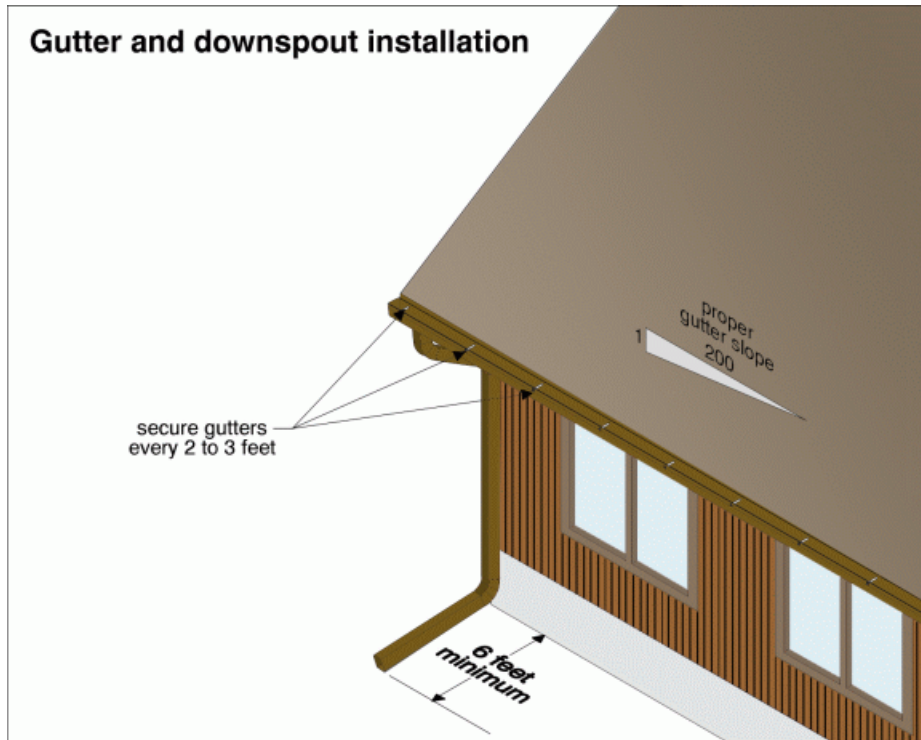
Downspout discharges too close to the building. Today's standards generally recommend that water should be diverted 10 ft. away from the house foundation. Recommend adding a splash block so that the water from the downspout can travel away from the building.

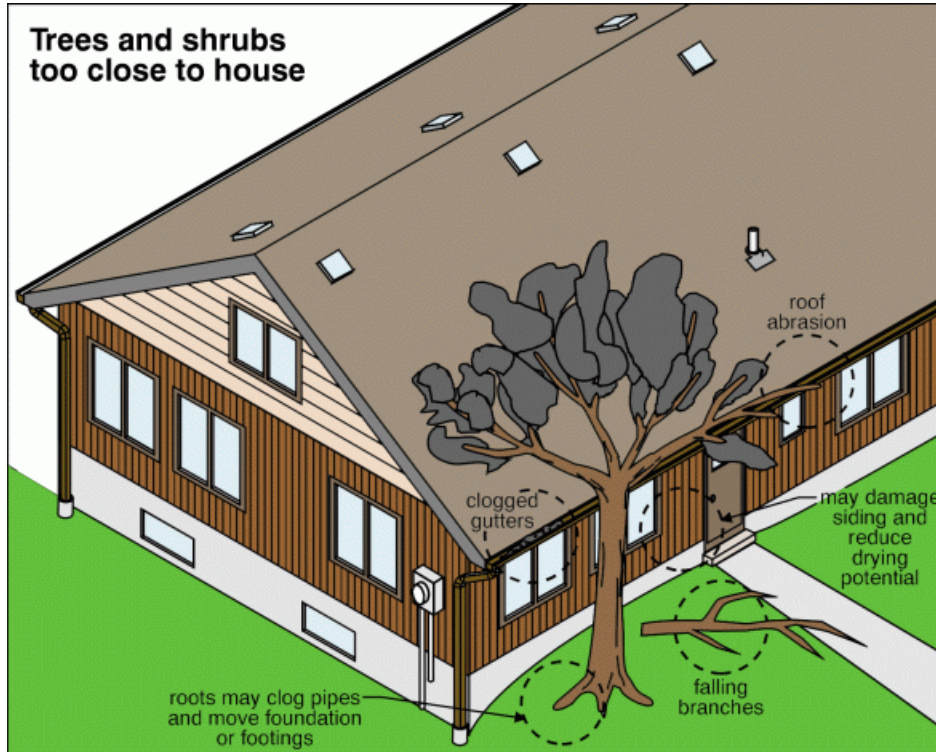
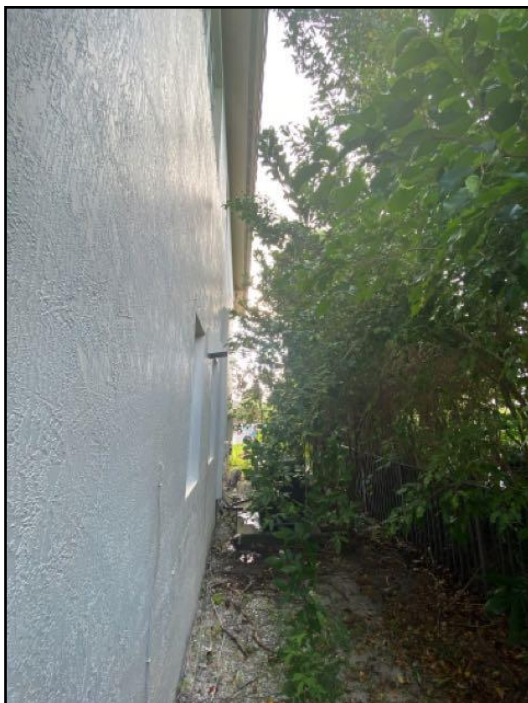
Recommending removing/trimming of trees or scrubs that are close to the building to mitigate moisture intrusion and pest from the building. Areas where trees and scrubs are close to the building may cause deterioration of building materials faster than the norm.

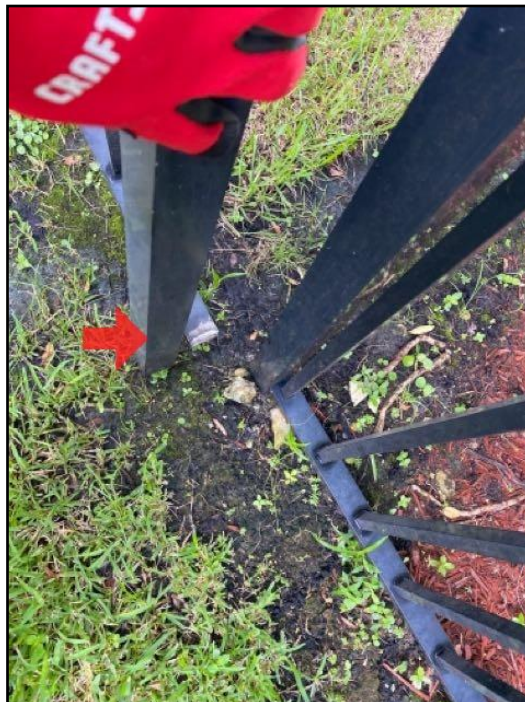
Fence entry is damaged. Recommend repairing to secure properly.

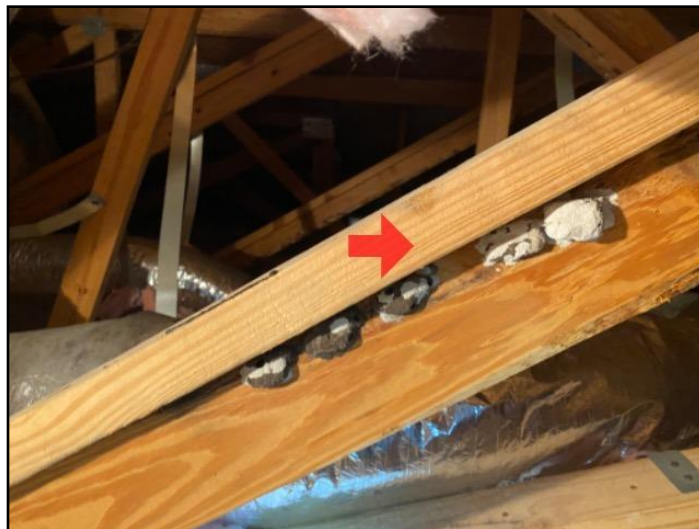
48.

Condition: • Wasp nest observed in the attic. Recommend removal.

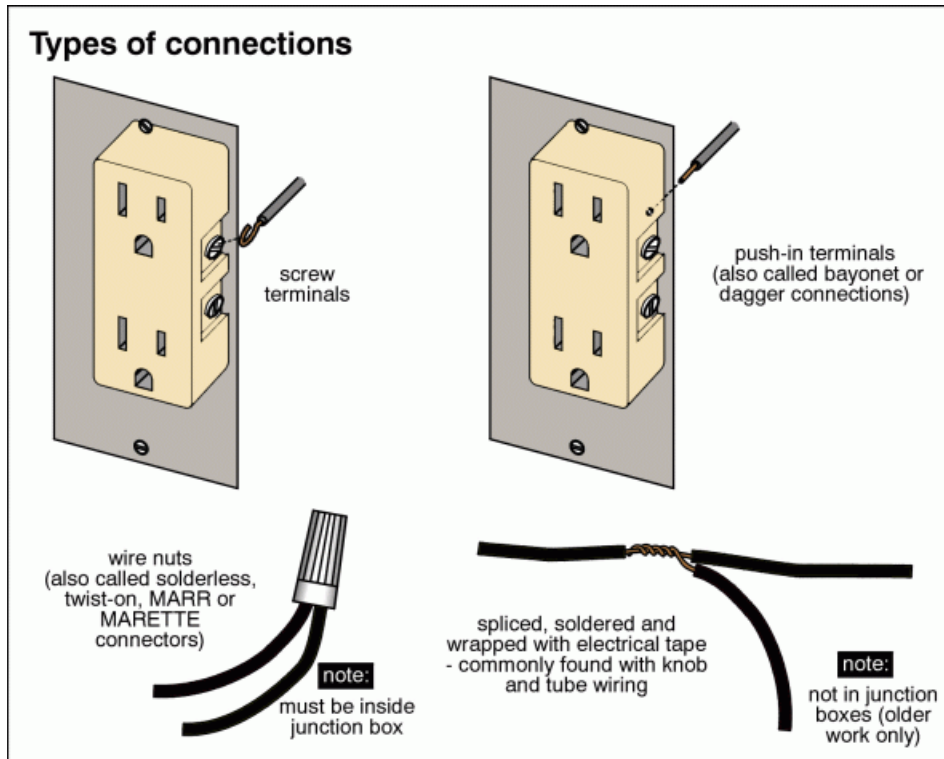
Missing covers, recommend replacing to remove risk for electrical shock/fire hazard.

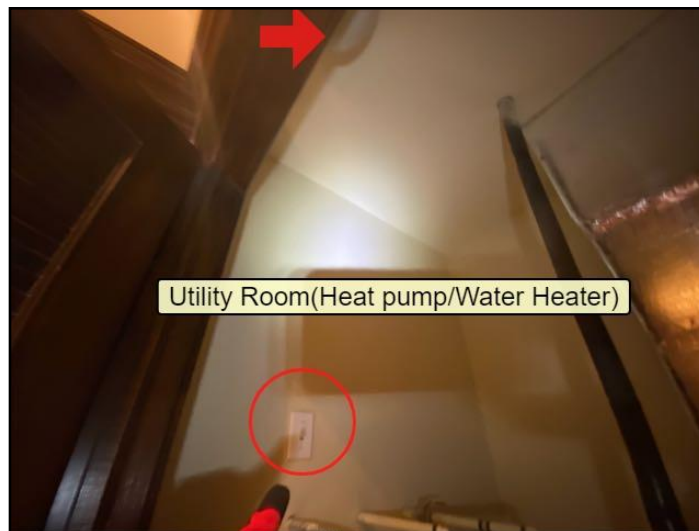
Inadequate lighting in the utility closet on the first floor. Recommend repair to improve visibility when servicing the units.

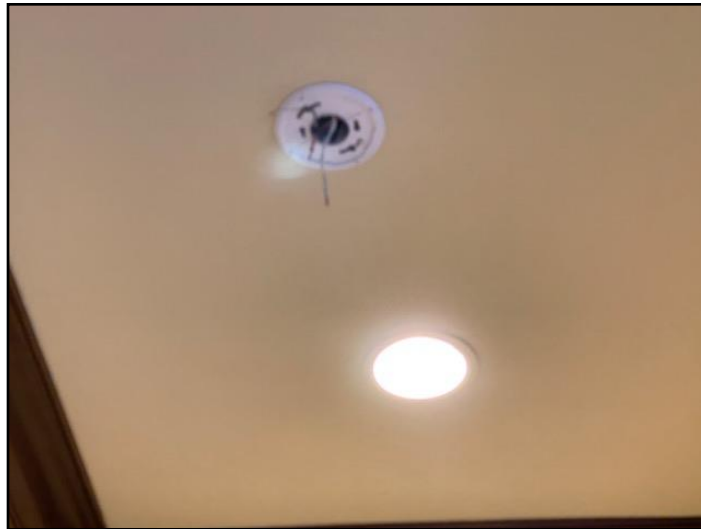
Recommend replacing missing smoke alarms. Safety issue.

86. *Missing*

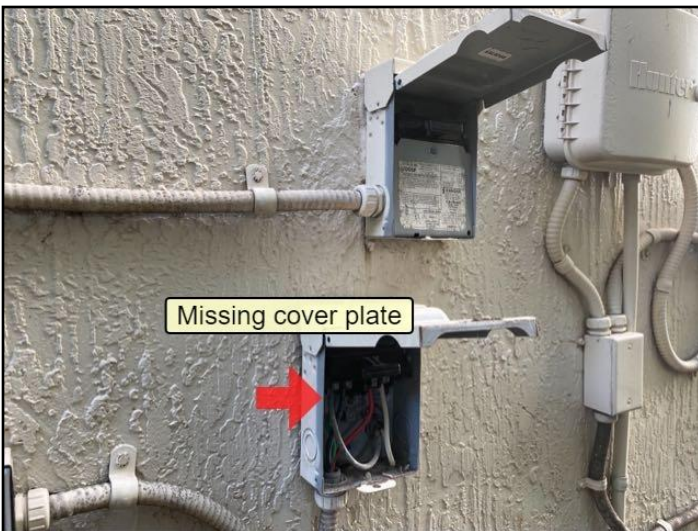
Service Disconnects for air compressors are present. One unit missing cover plate for wires.

87. Service Disconnects Present

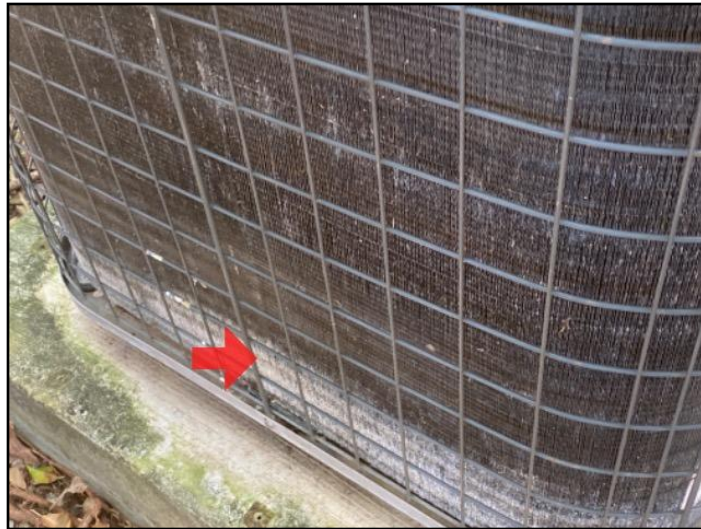
Recommend servicing ac units. Dirt/debris building on the units.

102. Service air conditioner

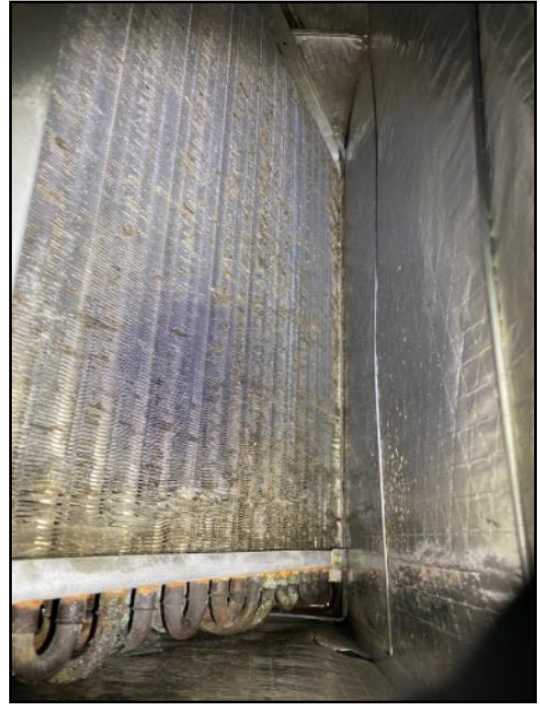
1st Floor Air Handler: Inside of unit is dirty and has presence of microbiological growth. Recommend cleaning, servicing and regular maintenance be conducted annually.

106. Dirty

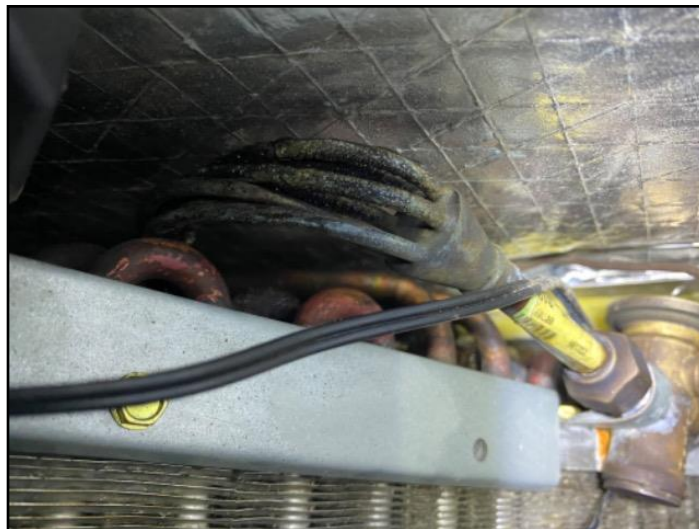
107. Dirty

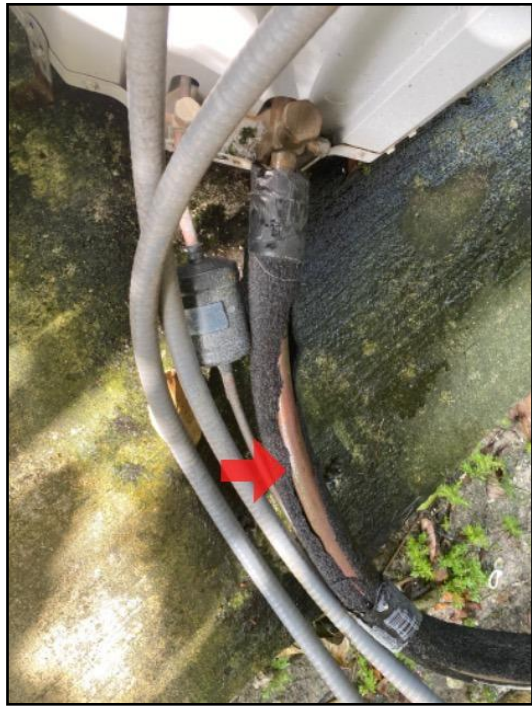
Insulation missing on the cold line. Recommend replacing to protect the the cold from damage.

117. Insulation - missing

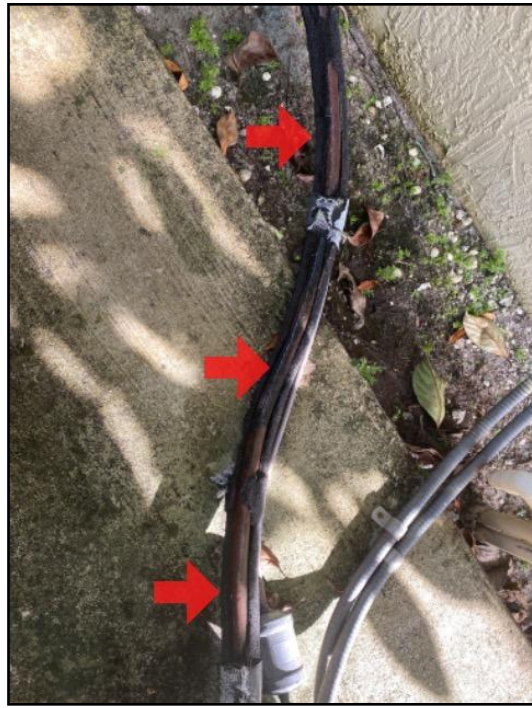
118. Insulation - missing

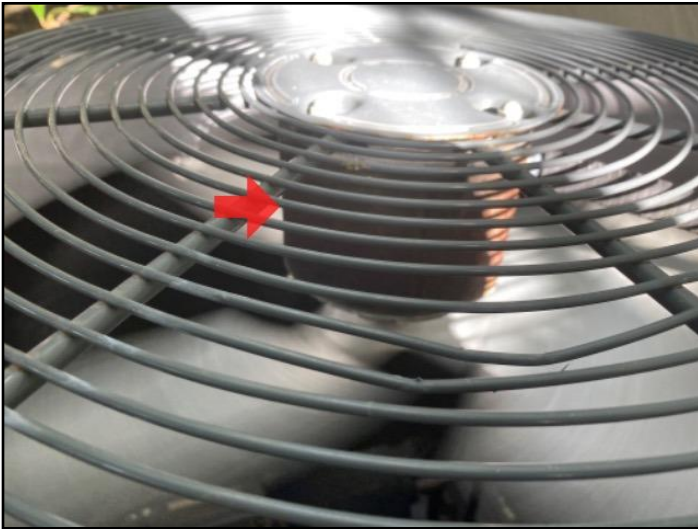
Condition: • Recommend servicing for air compressor and regular maintenance annually.

119. Rust on Fan Motor

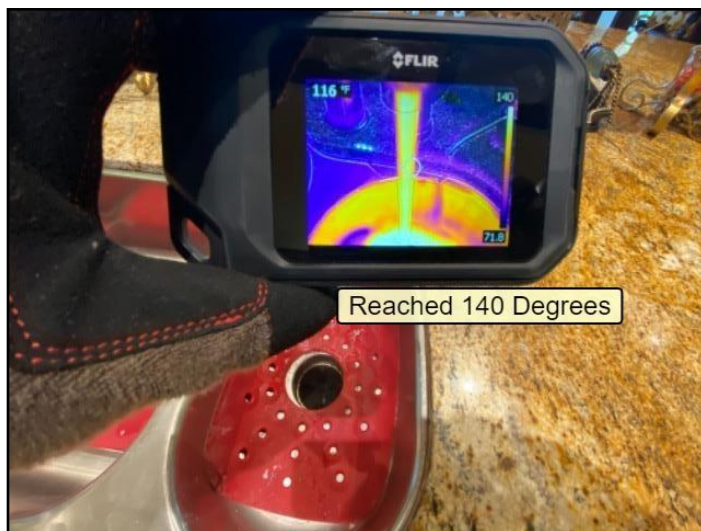
Recommend adjusting temperature to prevent risk to burning.

138. 135° F

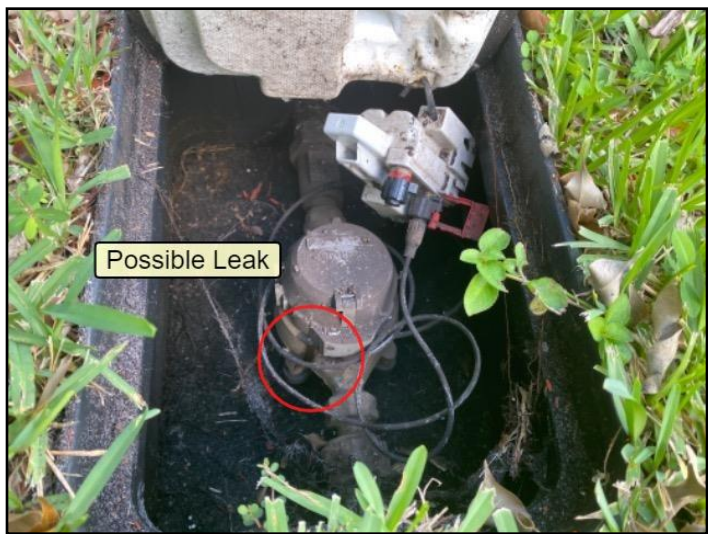
Water meter may have a leak, area around the meter are dry while the corner of the meter has a wet area. Recommend monitoring and further evaluation.

142. Leak

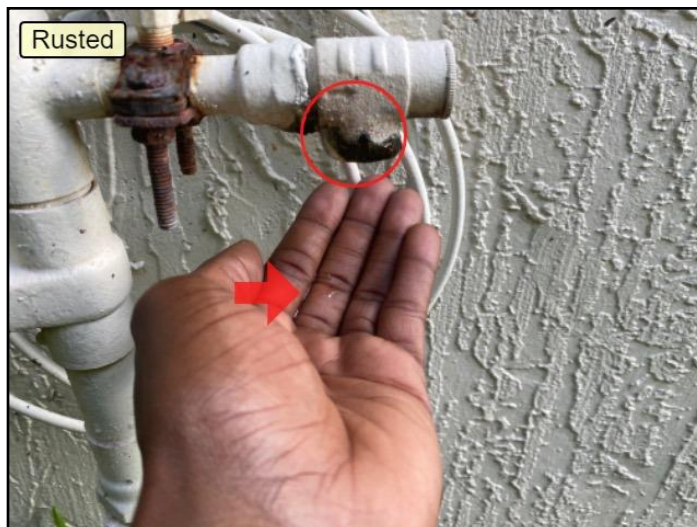
Condition: • [Leak or drip](#)
Bib is leaking. Recommend repair/replacement.

143. Leak or drip

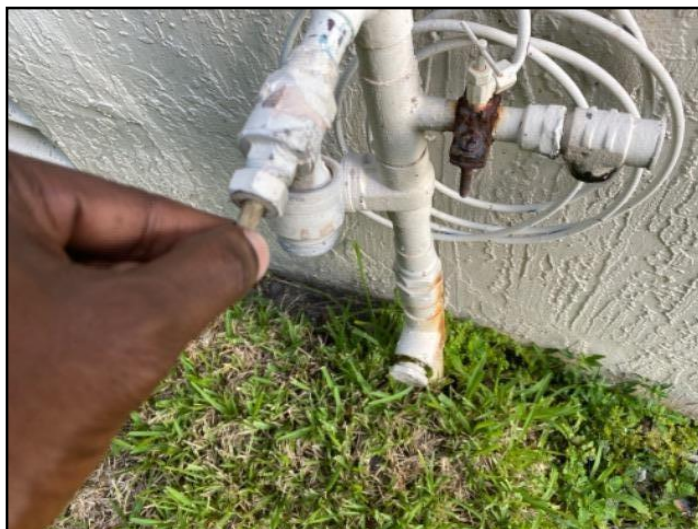
Missing knob to allow proper functioning of the water bib. Recommend replacement.

144. Inoperative

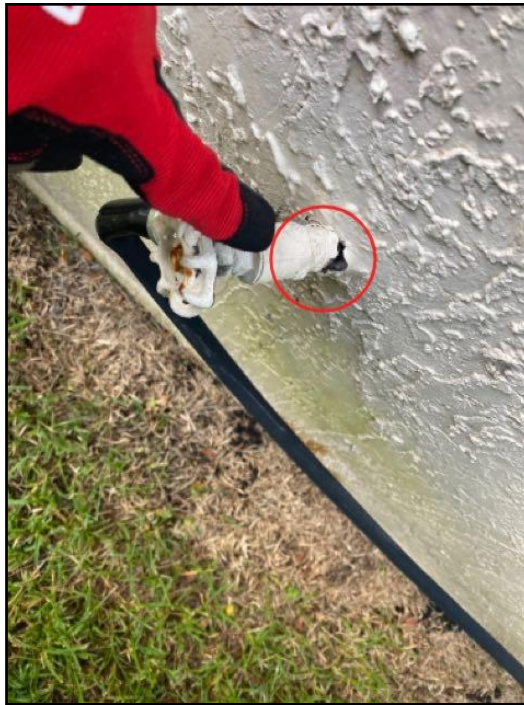
Water hose bib is damaged. Recommend repairing the crack in the wall and replacing the bib is discretionary as it is still functional. The crack can allow water intrusion into the wall and should be repaired to mitigate.

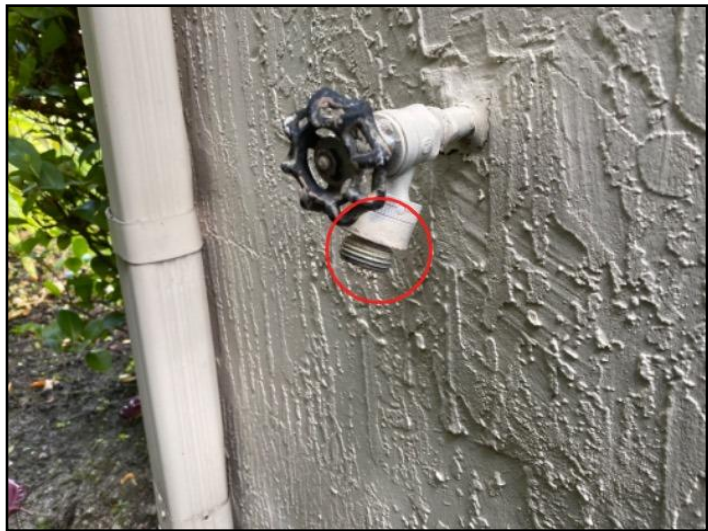
Recommend installing anti-syphon filter to prevent back flow into plumbing system.

146. Backflow prevention missing

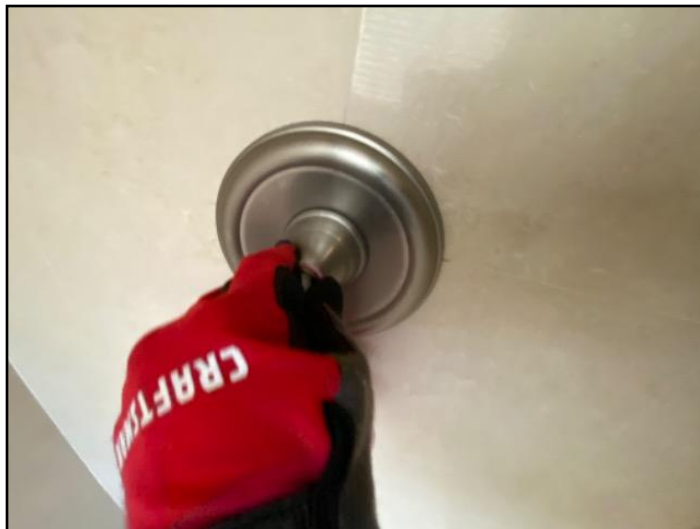
Handle is loose. Recommend repair to ensure fixture does not leak.

147. Loose

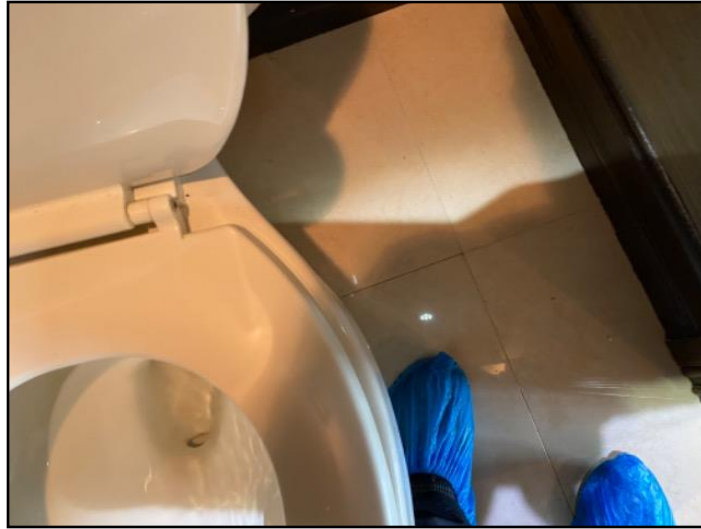
Toilet was loose at the closet flanges. Recommend repairs or replacement be conducted by a licensed plumber if needed.

148. *Loose*
