INSPECTION REPORT

For the Property at:
1830 SOUTHWEST 81ST AVENUE, 4416
NORTH LAUDERDALE, FL 33068

RE: Report No. 1137
1830 Southwest 81st Avenue, 4416
North Lauderdale, FL
33068

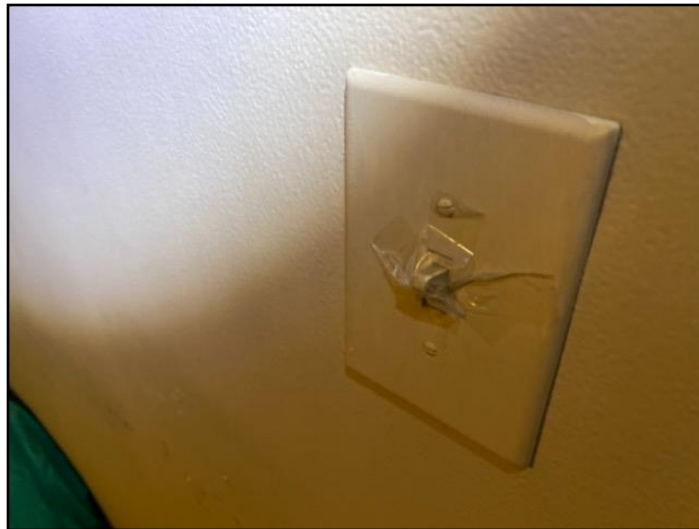
15. *Inoperative*

Condition: • [Inoperative](#)

Inoperative switch. Recommend requesting disclosure for why it's tapped in the on position.

Location: Bedroom

Task: Further Evaluation-Repair

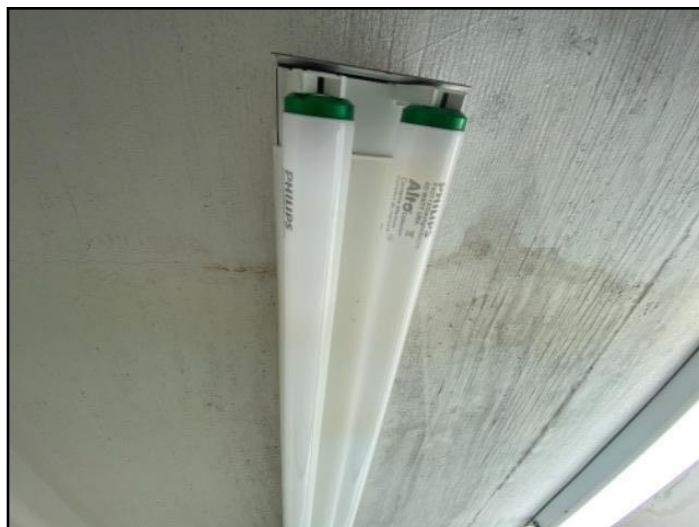
16. *Inoperative*

Condition: • [Inoperative](#)

Various light fixture throughout the home were inoperable during the time of the inspection. Recommend further evaluation to determine if light bulbs are needed or repairs are needed by a contractor.

Location: Throughout

Task: Further Evaluation

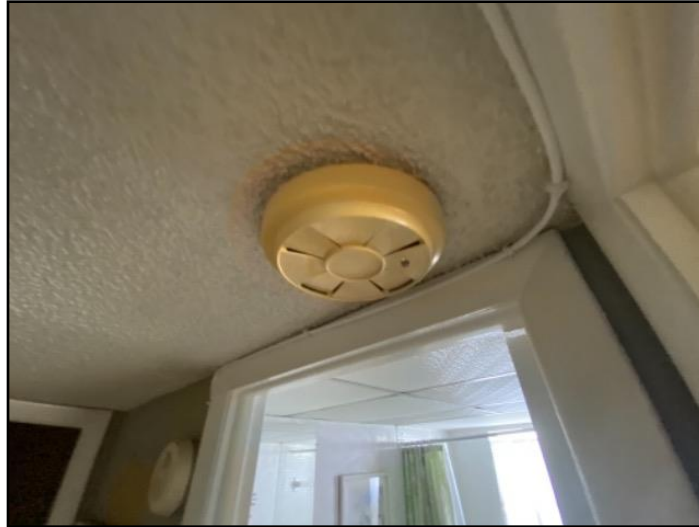
17. Inoperative

Condition: • Inoperative

CO detector did not alarm when tested. Recommend further evaluation and replacement if needed.

Location: Hallway Bathroom

Task: Replace

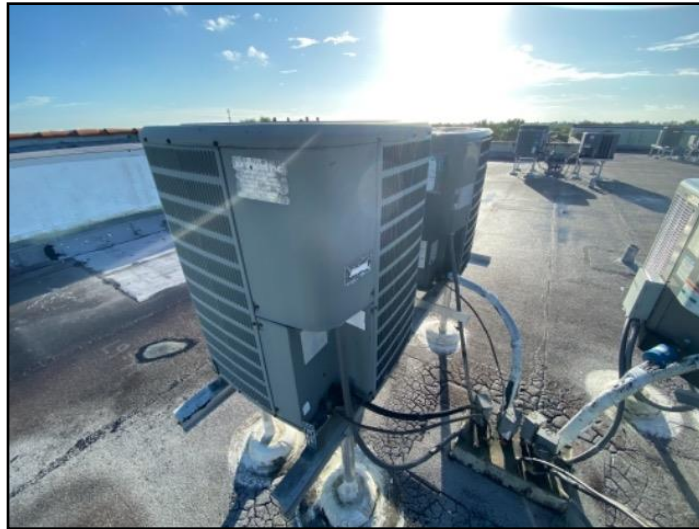
27. Electric

Compressor approximate age: • 16 years

Typical life expectancy: • 12 to 15 years

System data plate: • Air compressor located on the roof. Which unit is not confirmed. Markings missing.

Condition: • Past life expectancy

The average life span of central air-conditioning system is 12 to 15 years if it is properly installed and maintained. Recommend regular servicing and budgeting for replacement.

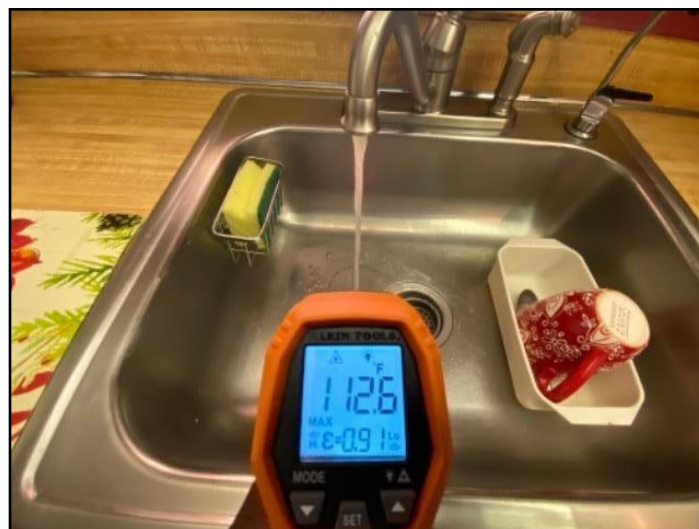
34. 115° F

Hot water temperature (Generally accepted safe temp. is 120° F):

• 115° F

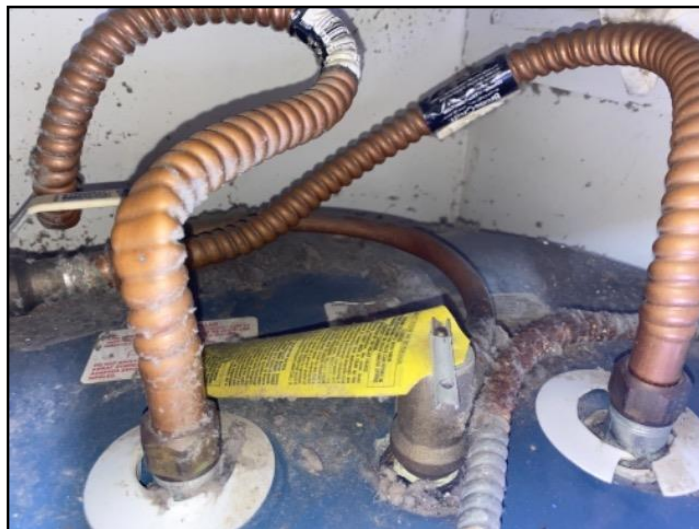
35.

Condition: • Service cable rusted. Recommend further evaluation and replacement of the cable if needed.

Implication(s): Fire Hazard

Location: Utility closet

Task: Further evaluation- Replace

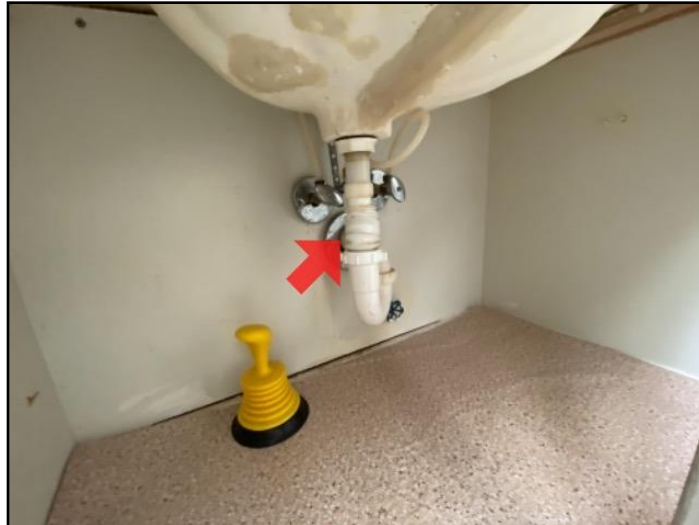
Condition: • [Slow drains](#)

Flexible PVC piping: the design of the pipe allows for debris to easily collect in the waste line. With the collection of all the goop, the drain begins to slowly clog and not drain properly. Recommend replacing to prevent slow drainage.

Location: Bathroom

Task: Repair or replace

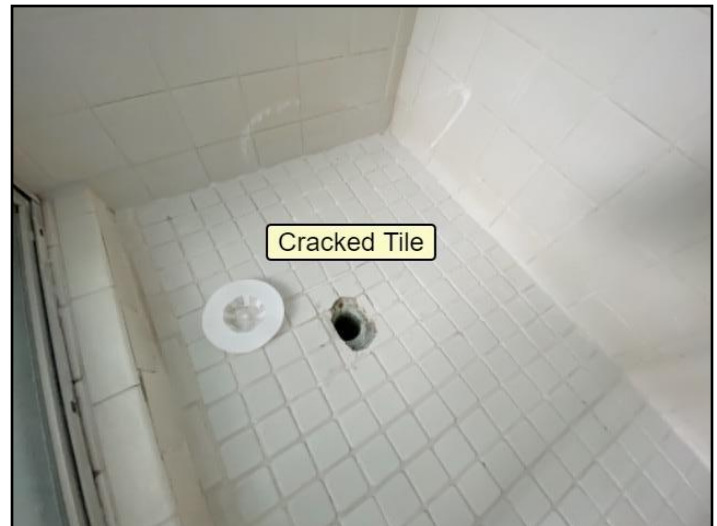
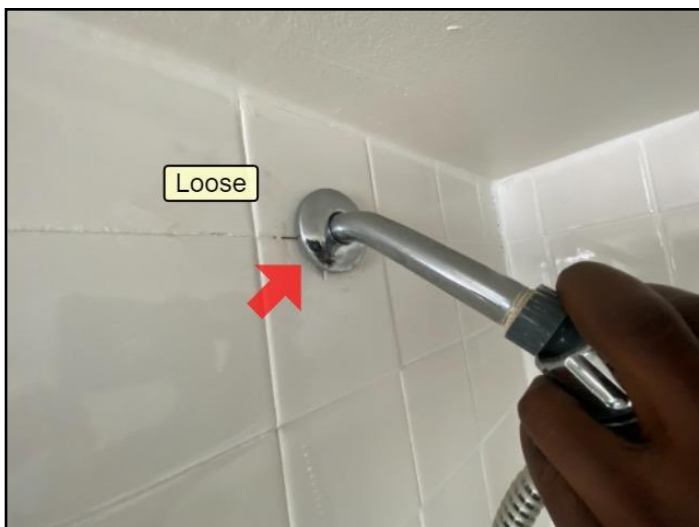
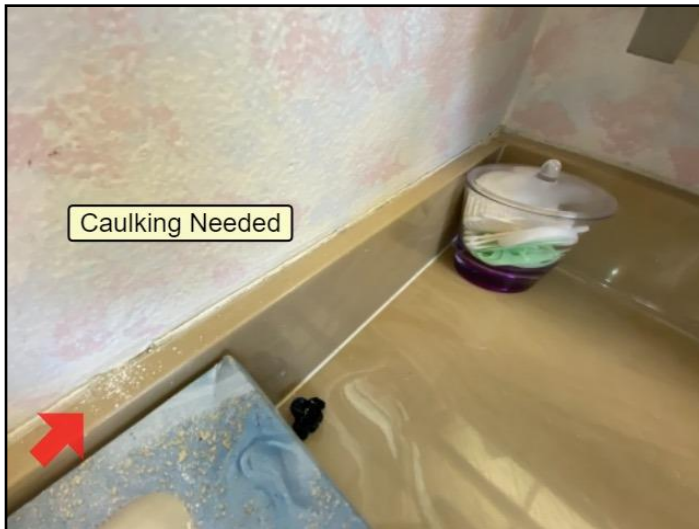
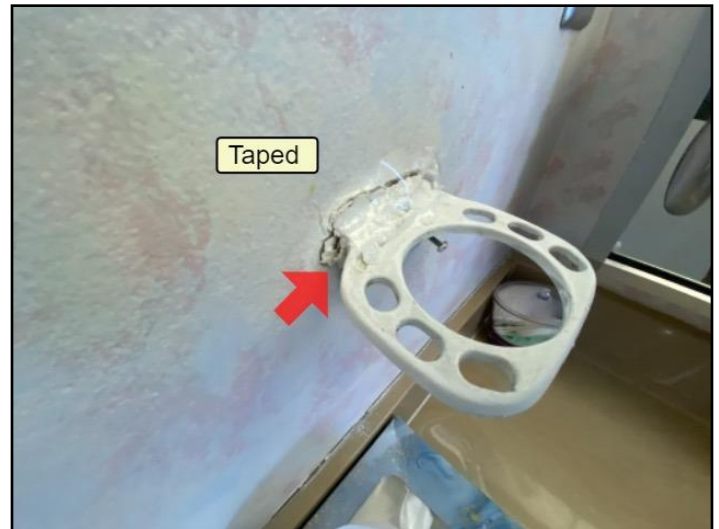
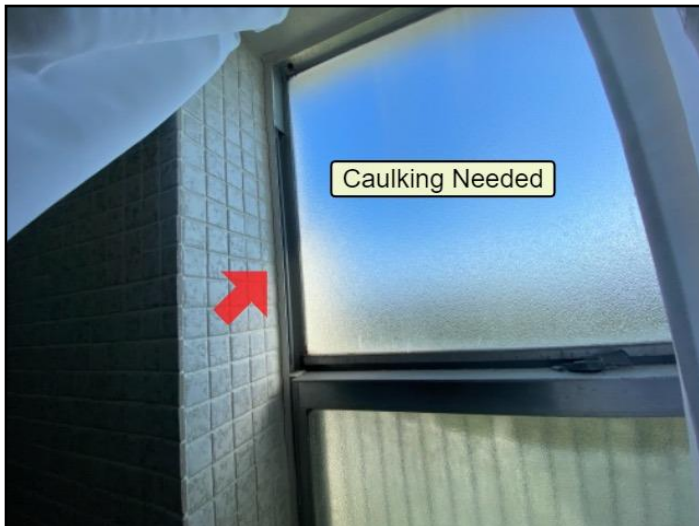
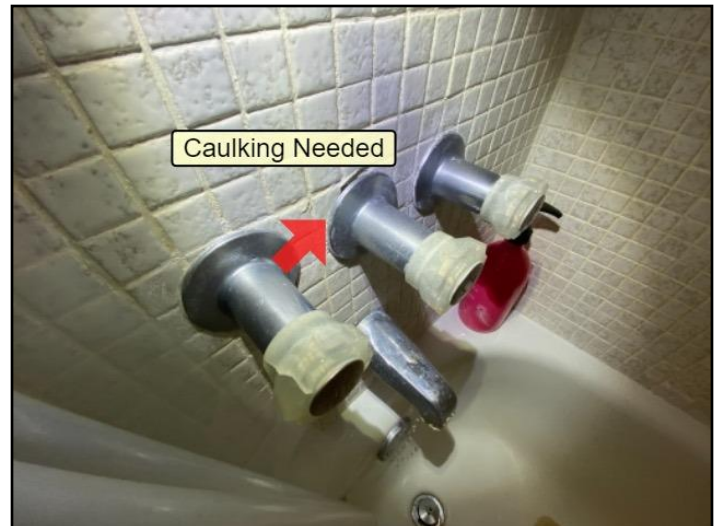
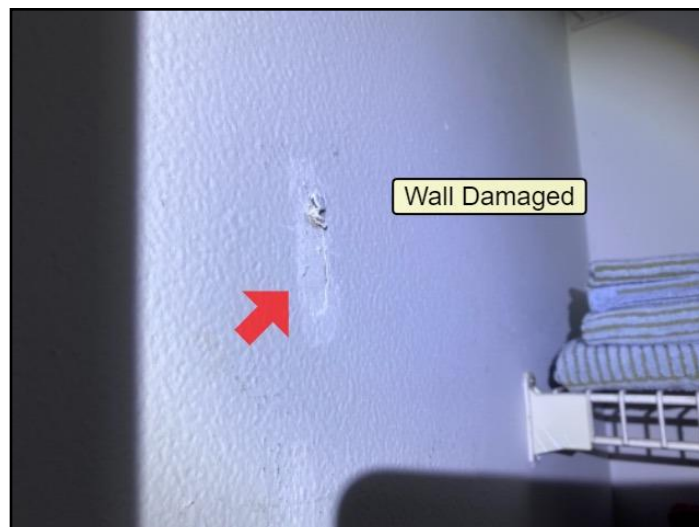
Condition: • Typical minor flaws

Typical flaws. Recommend improving and/or maintenance where needed.

Location: Various

Task: Improve

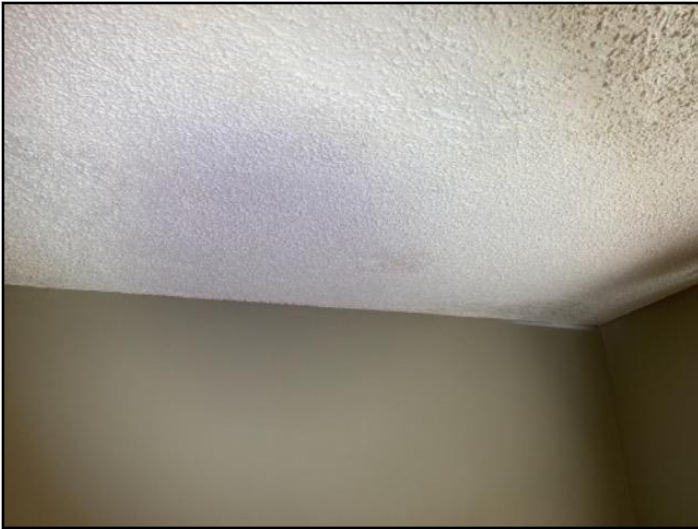
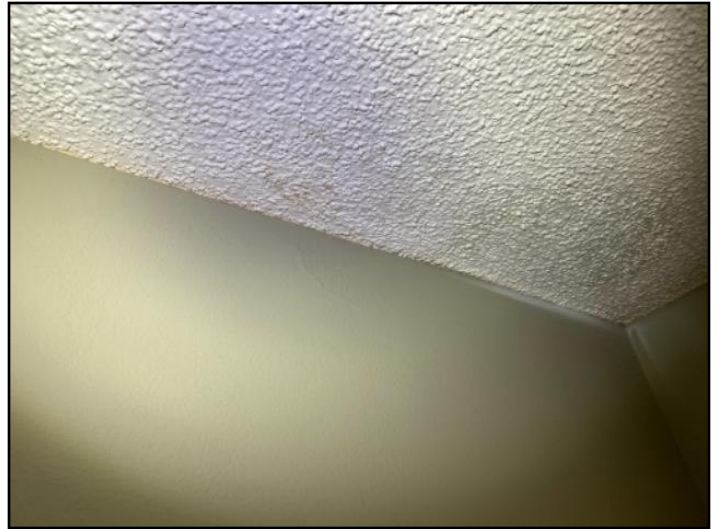
66. Water stains

Condition: • Possible leak or prior leak the master Bedroom. Ceiling was dry during inspection. Recommend Further evaluation and requesting disclosure from seller or HOA.

Condition: • Water stains

Observed what could be water stains on the ceiling in the bedroom. Inspector could not confirm root cause of stains or moisture presence. Recommend requesting disclosure from seller about the area.

Task: Further evaluation Monitor

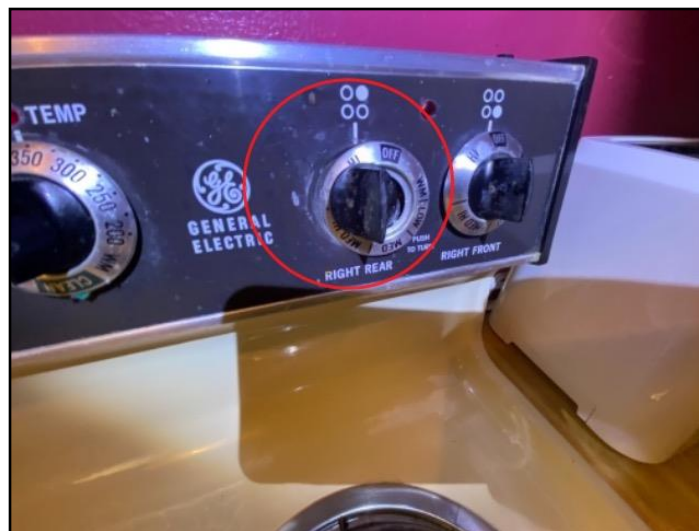
68. Knobs broken

Condition: • Knobs broken

Knob damaged. Recommend replace or replace.

Task: Repair or replace
