INSPECTION REPORT

For the Property at:
8309 NORTHWEST 123RD
PARKLAND, FL 33076

Prepared for: SAMPLE REPORT
Inspection Date: Friday, August 28, 2020
Prepared by: RONALD GLADDEN, HI12801

RE: Report No. 1055
8309 Northwest 123rd
Parkland, FL
33076

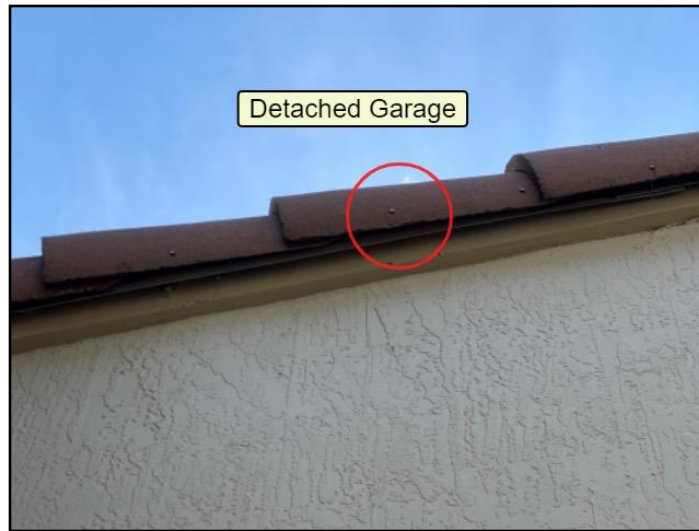
20. *Exposed fasteners not sealed*

Exposed fasteners on the detached garage. Recommend sealing to keep water from deteriorating the fasteners faster than normal.

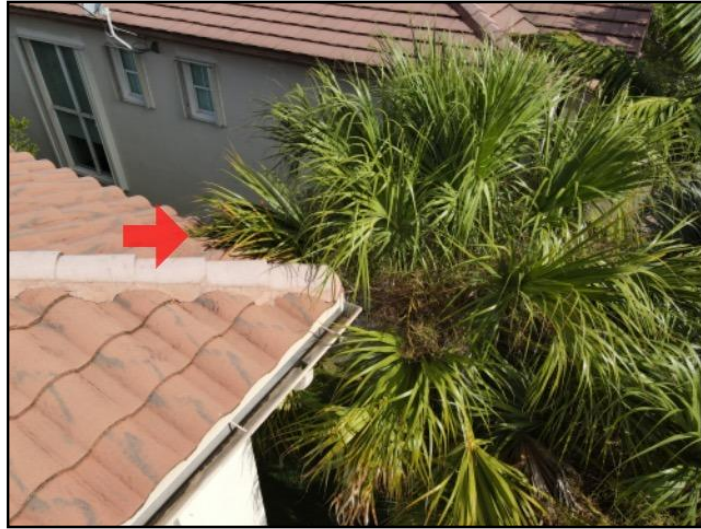
38. Trees or shrubs too close to building

Condition: • [Trees or shrubs too close to building](#)

Recommending removing/trimming of trees or scrubs that are close to the building to mitigate moisture intrusion and pest from the building. Areas where trees and scrubs are close to the building may cause deterioration of building materials faster than the norm.

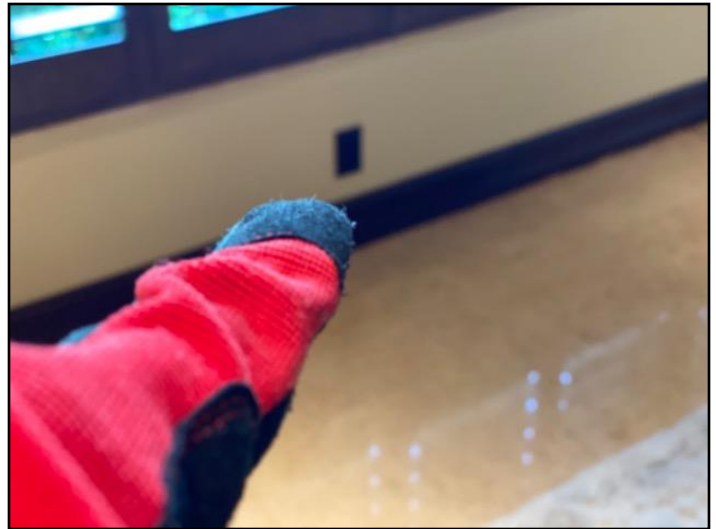
75. 1st Floor Outlet - Westside

Missing covers, recommend replacing to remove risk for electrical shock/fire hazard.

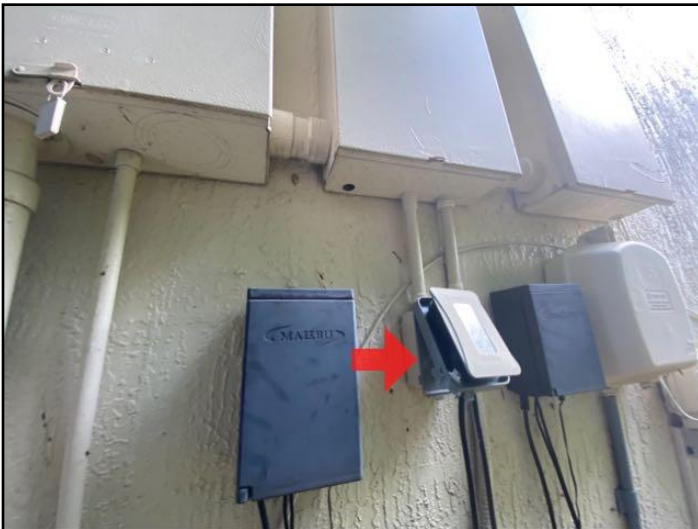
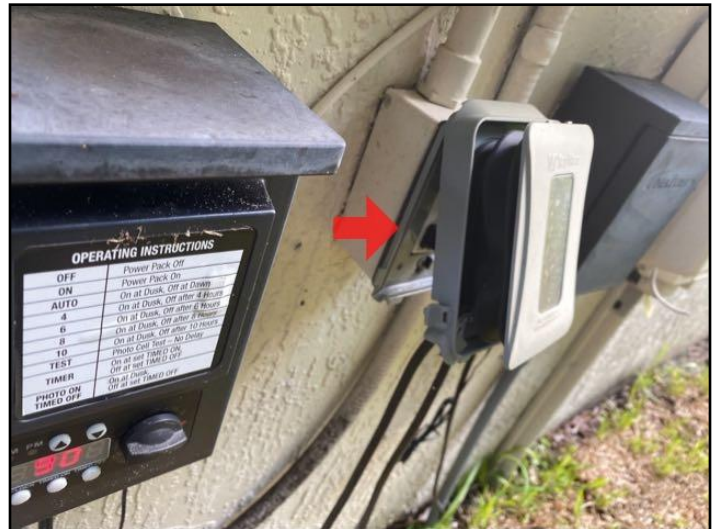
Condition: • Electrical cords are exposed to water intrusion. Recommend seeking a more permanent solution for the wiring to be protected. Seek assistance of an licensed electrician if needed for evaluation.

Implication(s): Fire Hazard

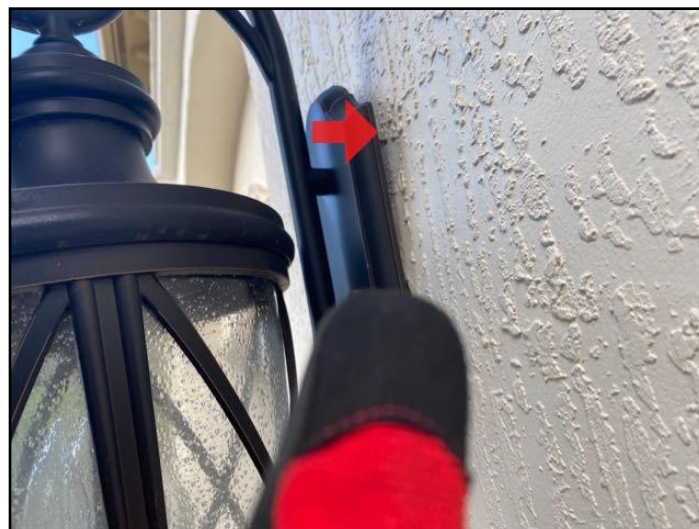
Condition: • Recommend caulking behind outdoor light fixtures to keep water from entering the fixtures.

Implication(s): Fire Hazard

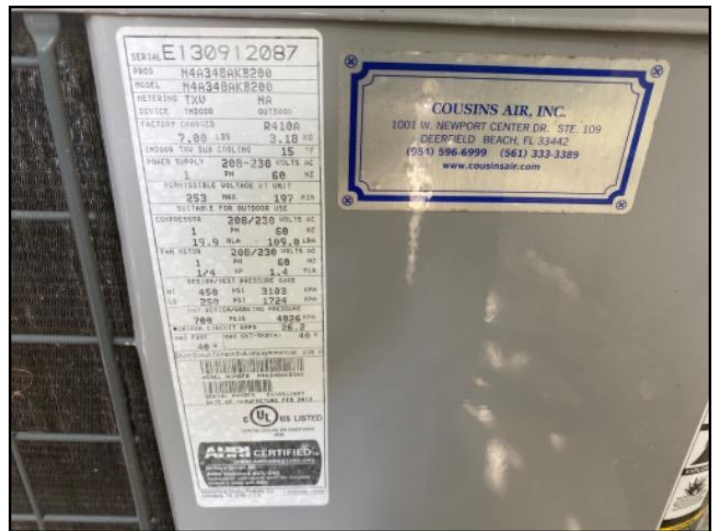
Service Disconnects for air compressors are present. One unit missing cover plate for wires.

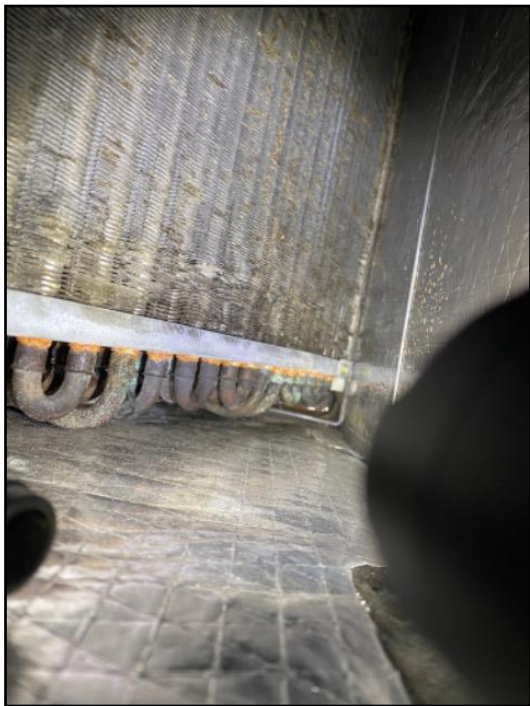
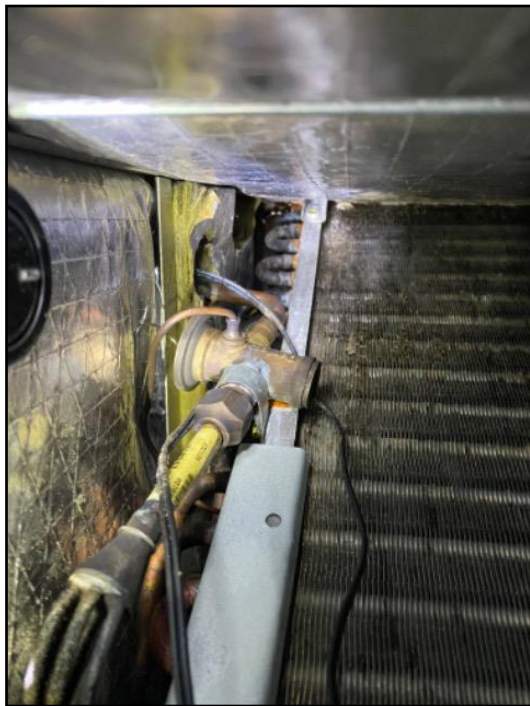
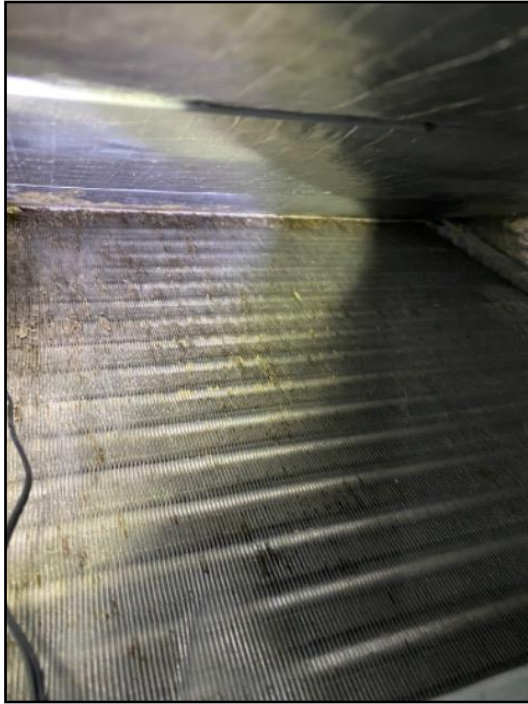
Condition: • [Dirty](#)

1st Floor Air Handler: Inside of unit is dirty and has presence of microbiological growth. Recommend cleaning, servicing and regular maintenance be conducted annually.

Task: Service Clean

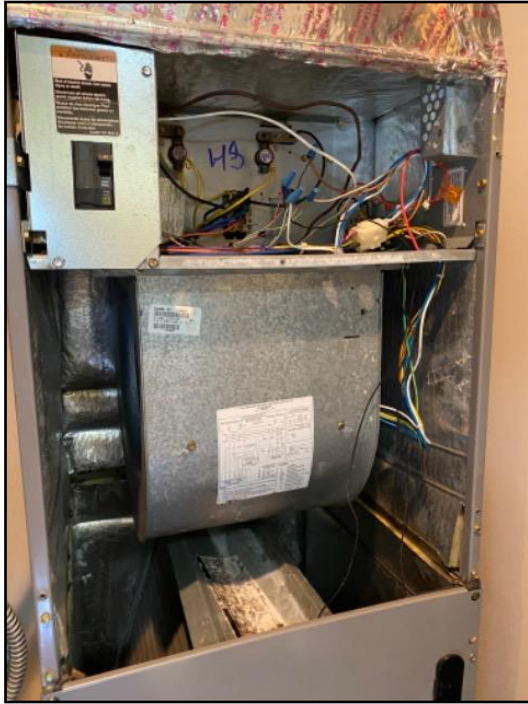
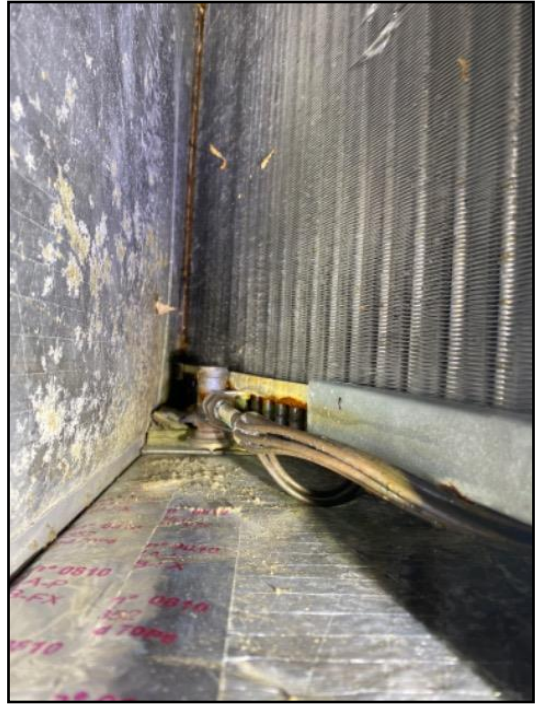
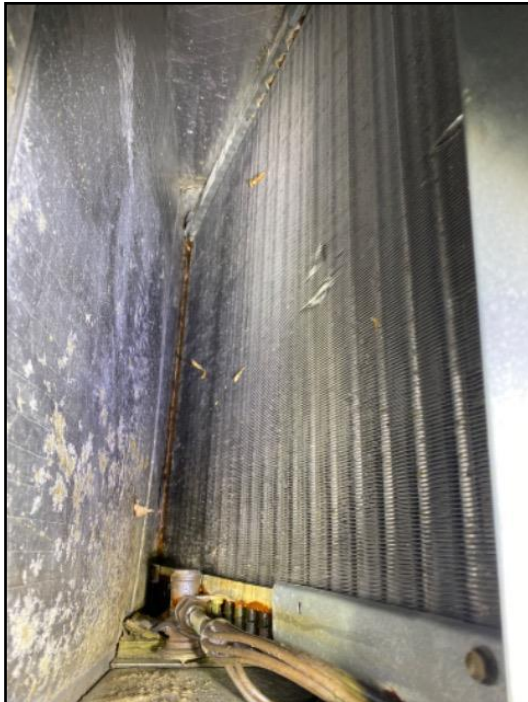
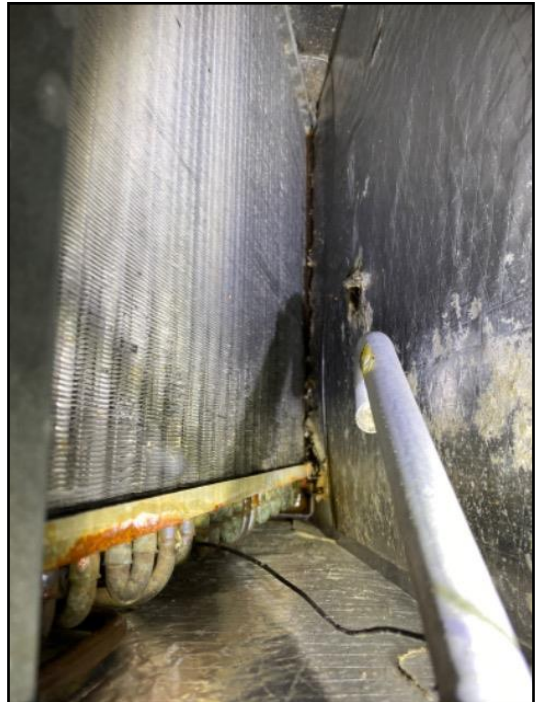
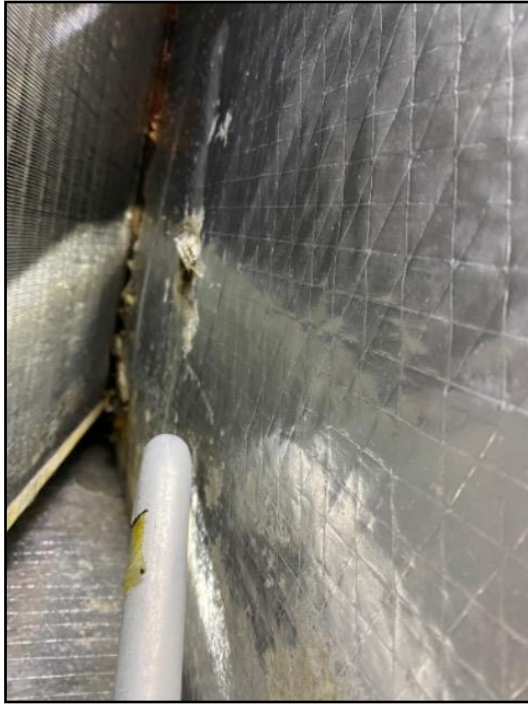
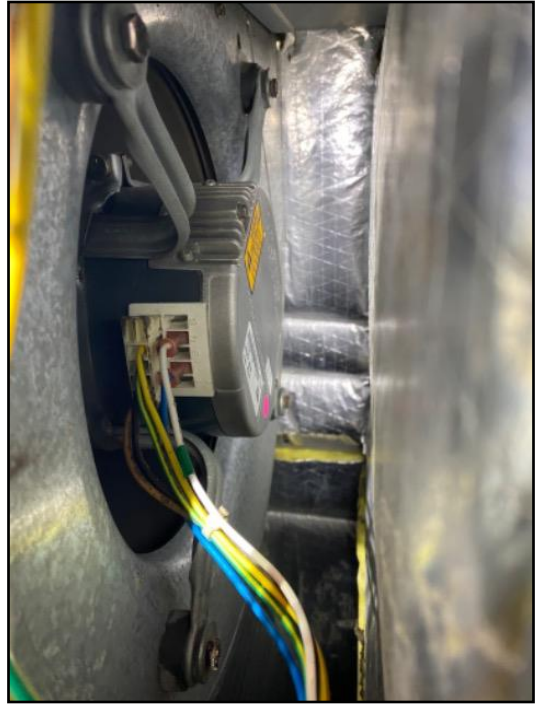
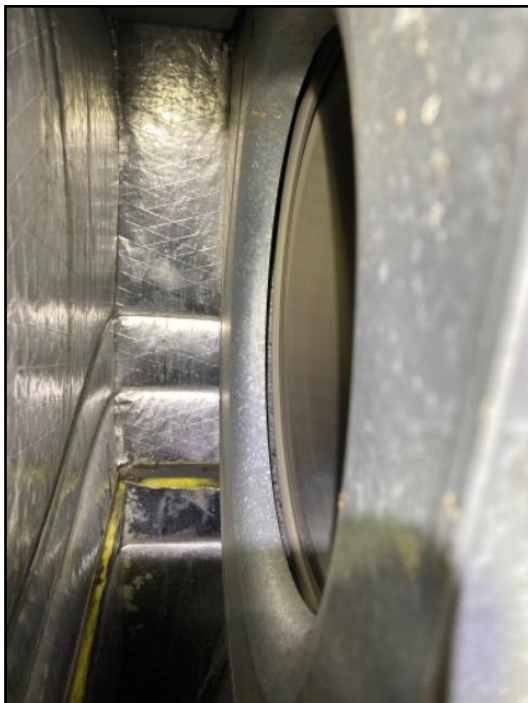
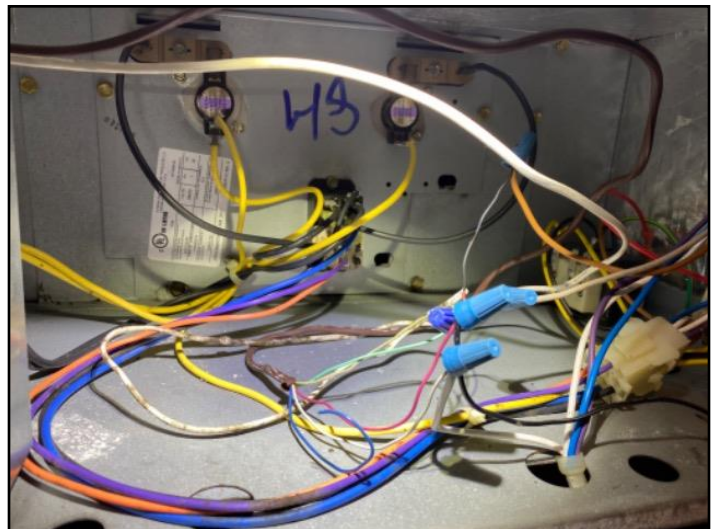
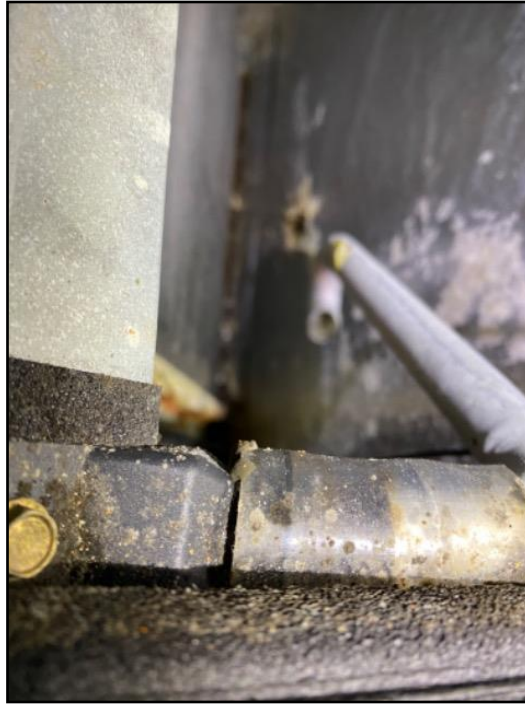
Condition: • Service air conditioner

Recommend servicing ac units. Dirt/debris building on the units.

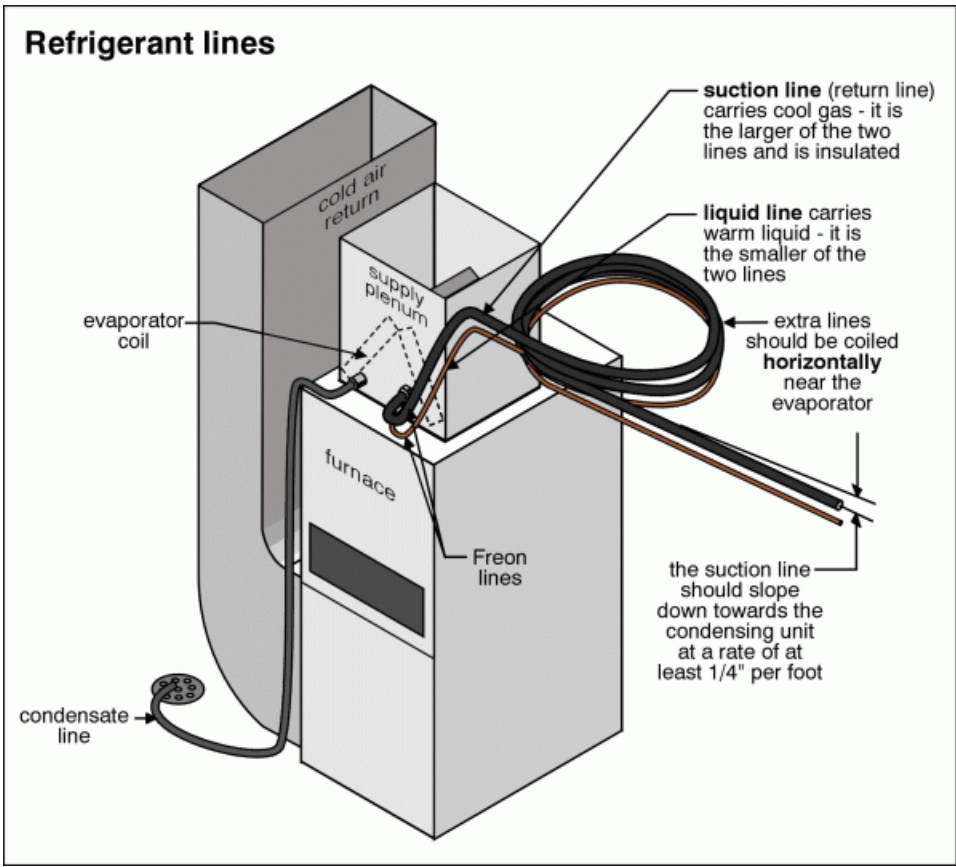
117. Insulation - missing

Condition: • [Insulation - missing](#)

Insulation missing on the cold line. Recommend replacing to protect the the cold from damage.

Task: Replace

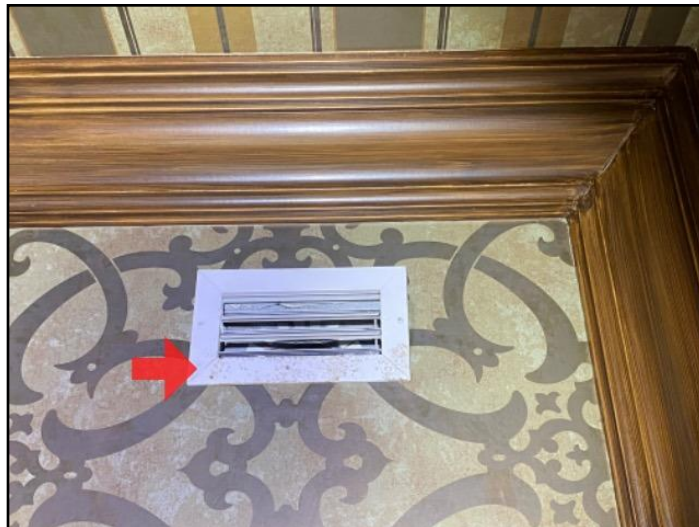
Condition: • [Dirty](#)

Dirt/Debris around the air vent in the hallway bathroom. Recommend cleaning.

Task: Clean

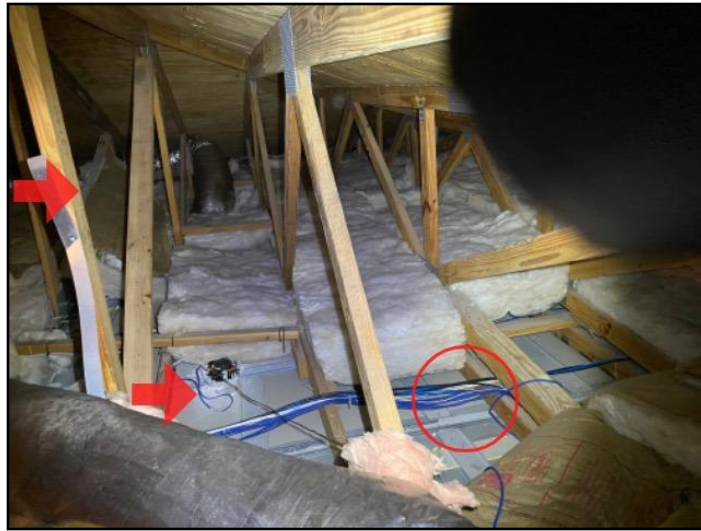
Condition: • [Gaps or voids](#)

Insulation has been moved from its original installation in multiple areas. Recommend replacing or adding insulation to these areas to mitigate conditioned air escaping to the attic or hot air into the home.

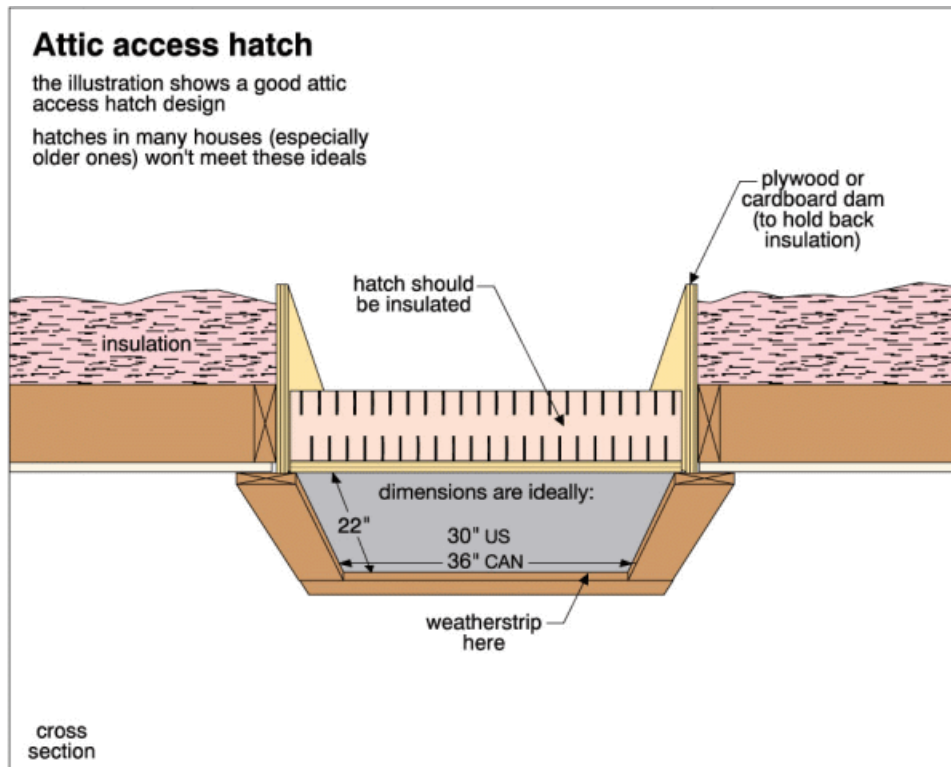
Condition: • [Not insulated and not weatherstripped](#)

Task: Improve

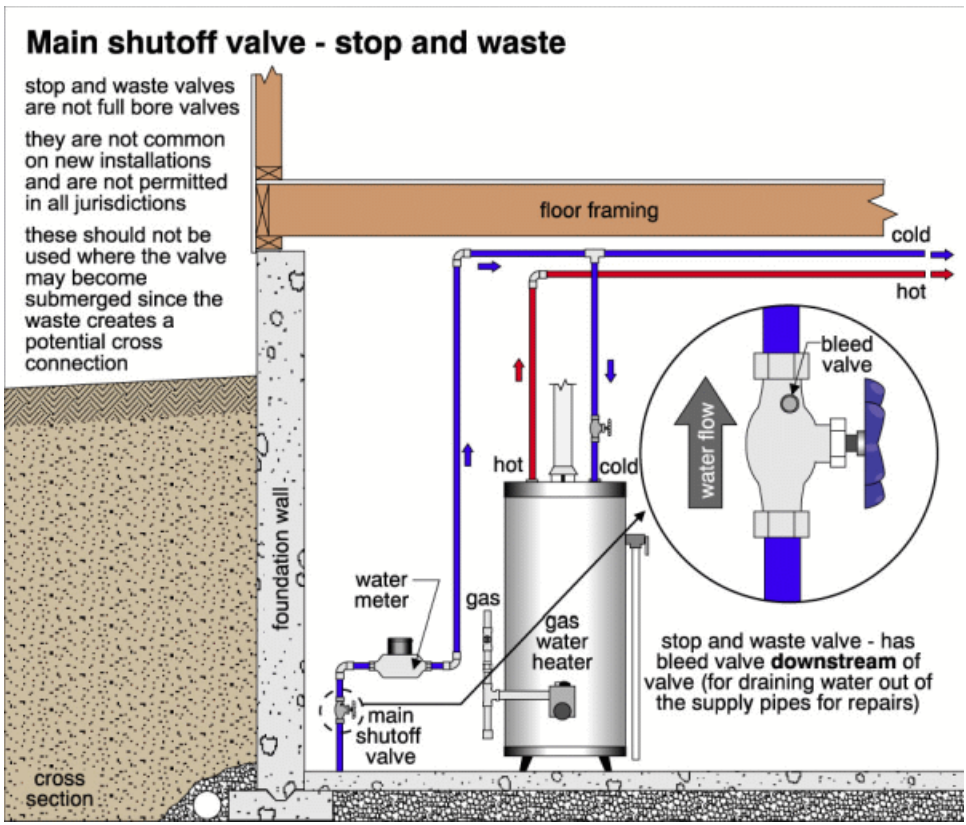
142. Leak

Condition: • [Leak](#)

Water meter may have a leak, area around the meter are dry while the corner of the meter has a wet area. Recommend monitoring and further evaluation.

Task: Further evaluation

Time: As soon as possible

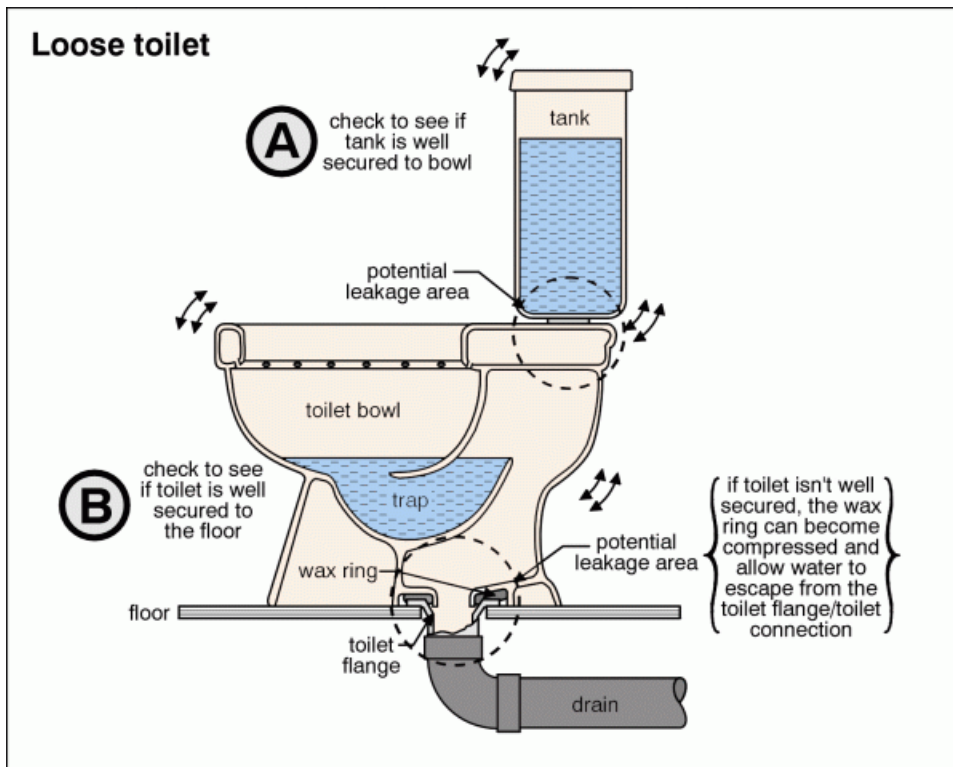
148. *Loose*

Condition: • [Loose](#)

Toilet was loose at the closet flanges. Recommend repairs or replacement be conducted by a licensed plumber if needed.

Task: Repair

Time: As soon as possible
